# THE FAILURE OF THE TACOMA NARROWS BRIDGE

A Report to the  
Honorable John M. Carmody  
Administrator, Federal Works Agency  
Washington, D. C.

## BOARD OF ENGINEERS

MARCH 28, 1941

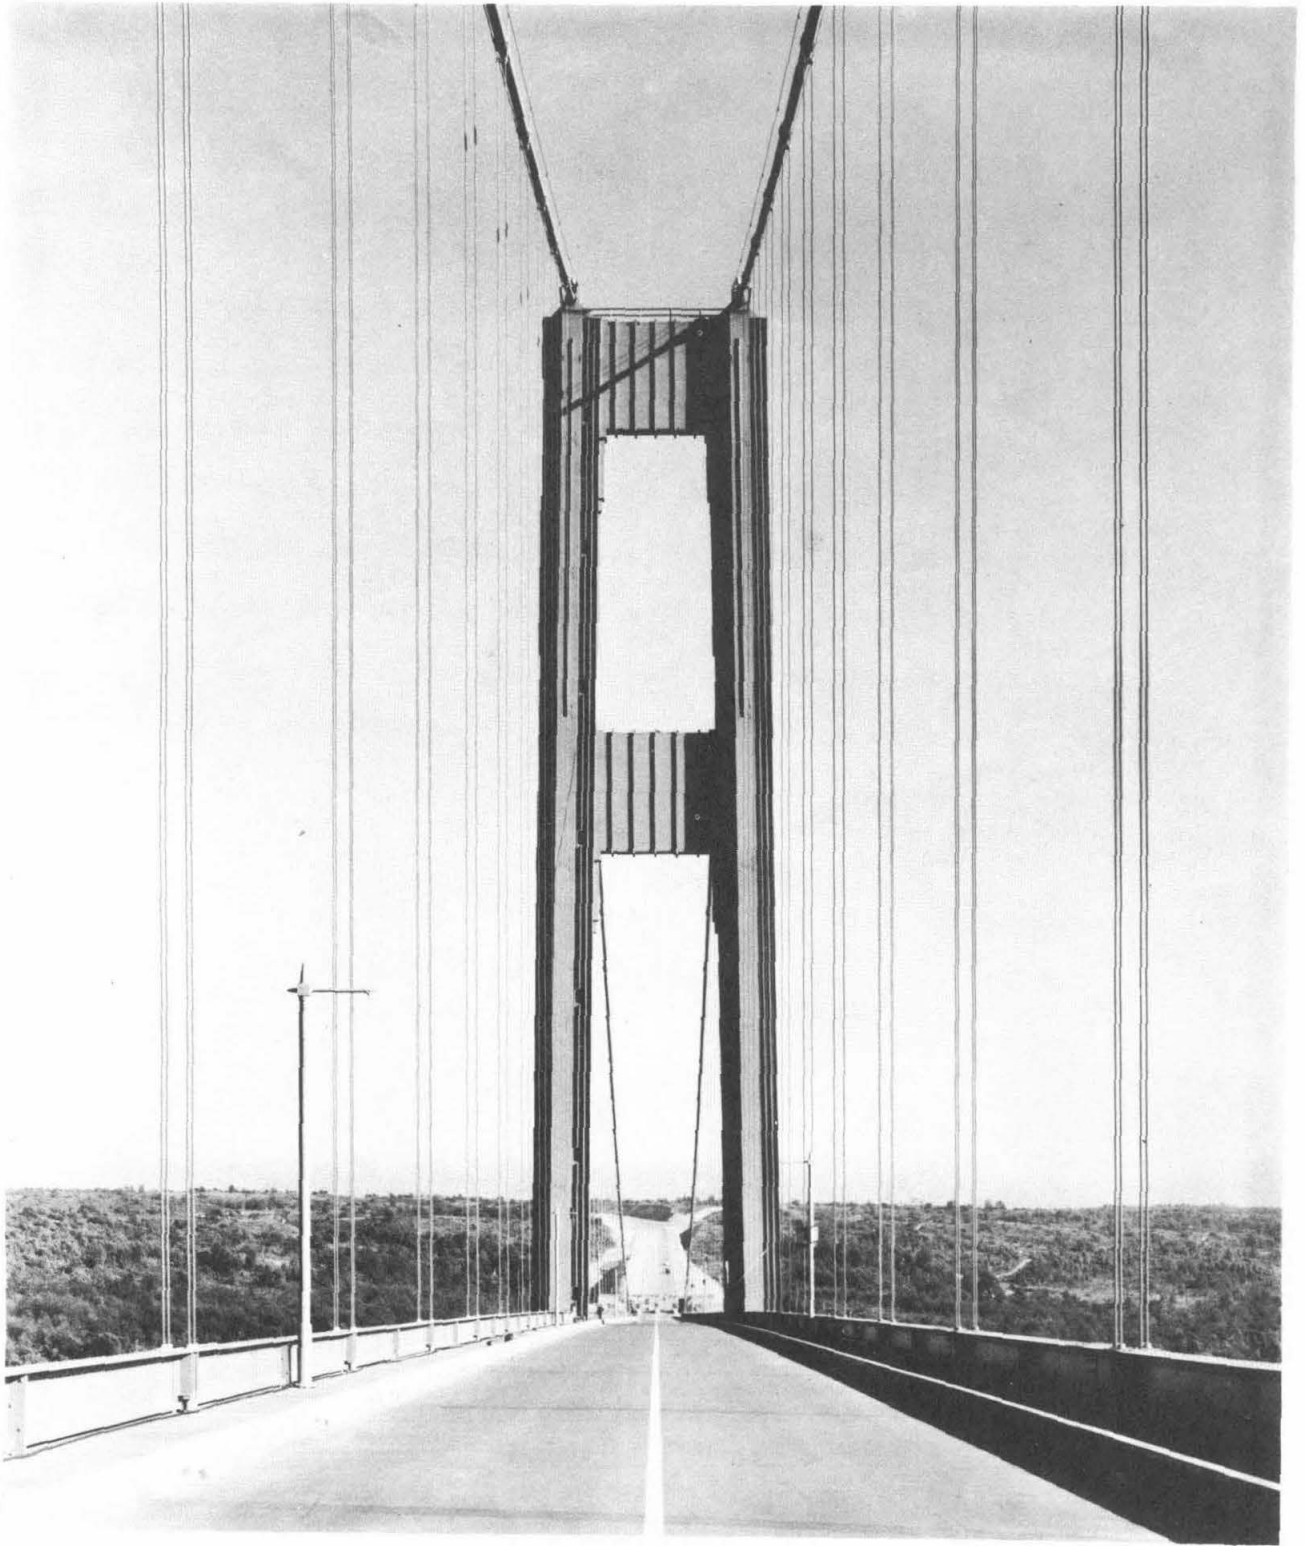
Fig. 1. Tacoma Narrows Bridge Along Roadway.

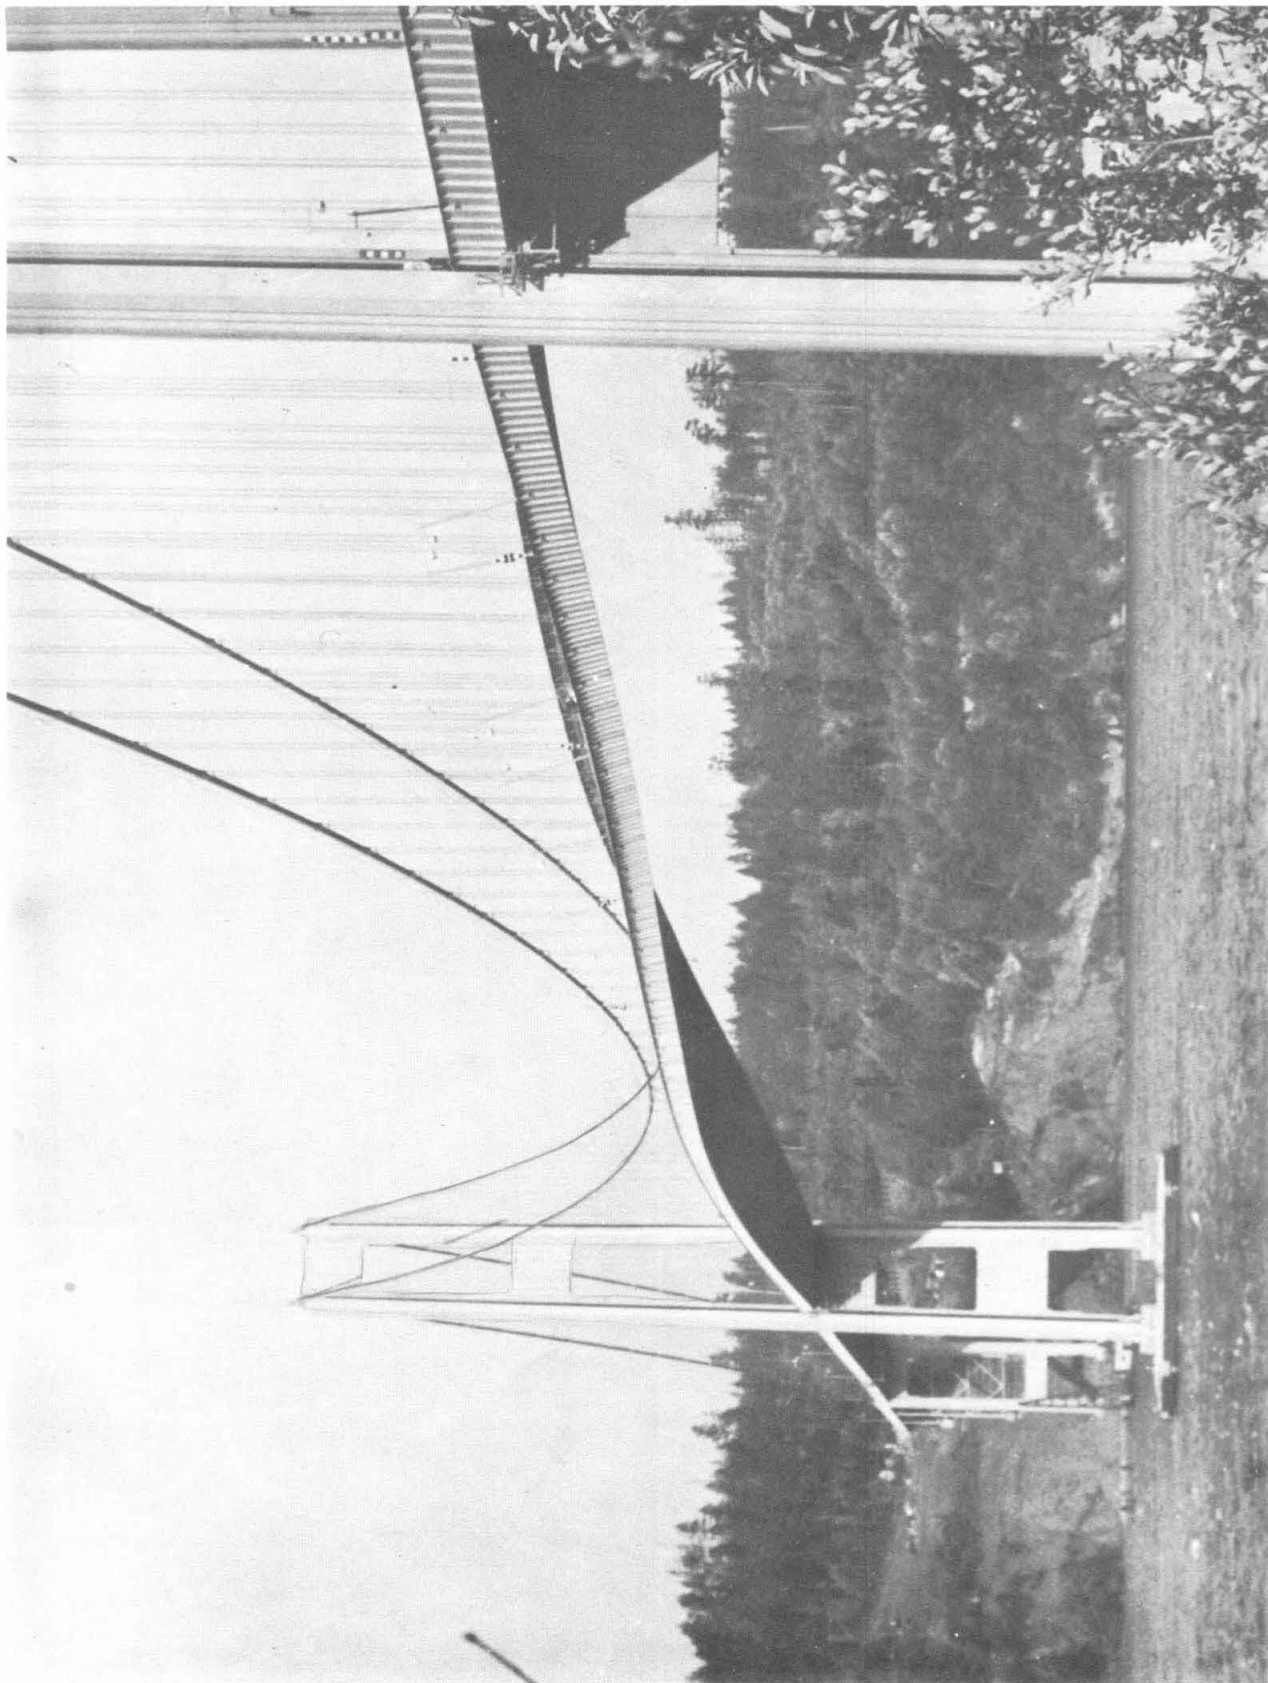
Fig. 2. One Node Torsional Oscillation of Bridge  
about one Hour before Final Failure.

Suddenly, at approximately 10:00 A.M., the center span developed a torsional movement with a node at mid span. The frequency suddenly changed from 37 to 14. At the quarter points, the angle of rotation was observed as nearly 45 degrees each way, the amplitude of the cable movement being approximately 28 feet. Shortly after the start of this violent

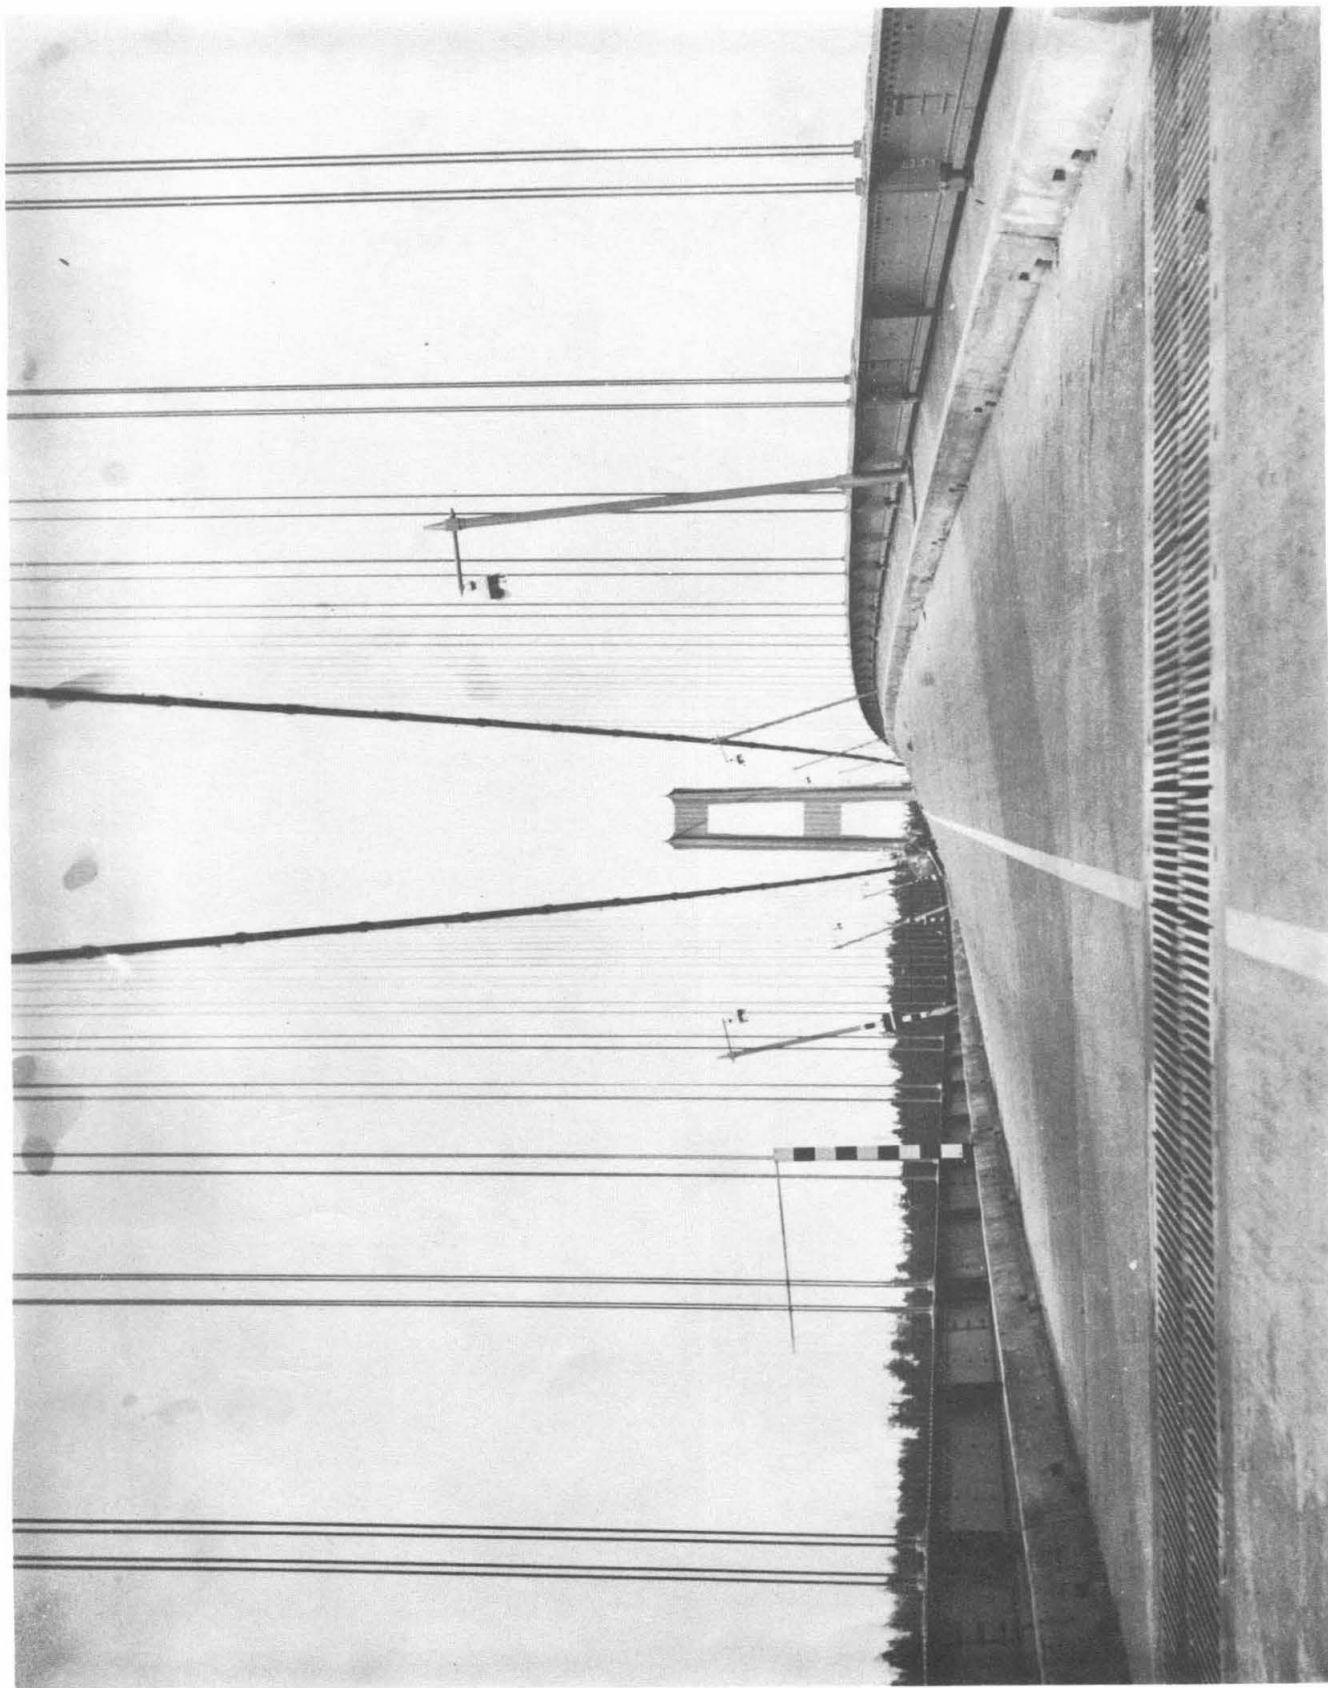
Fig. 3. Torsion of Floor Center Span seen from Tower.

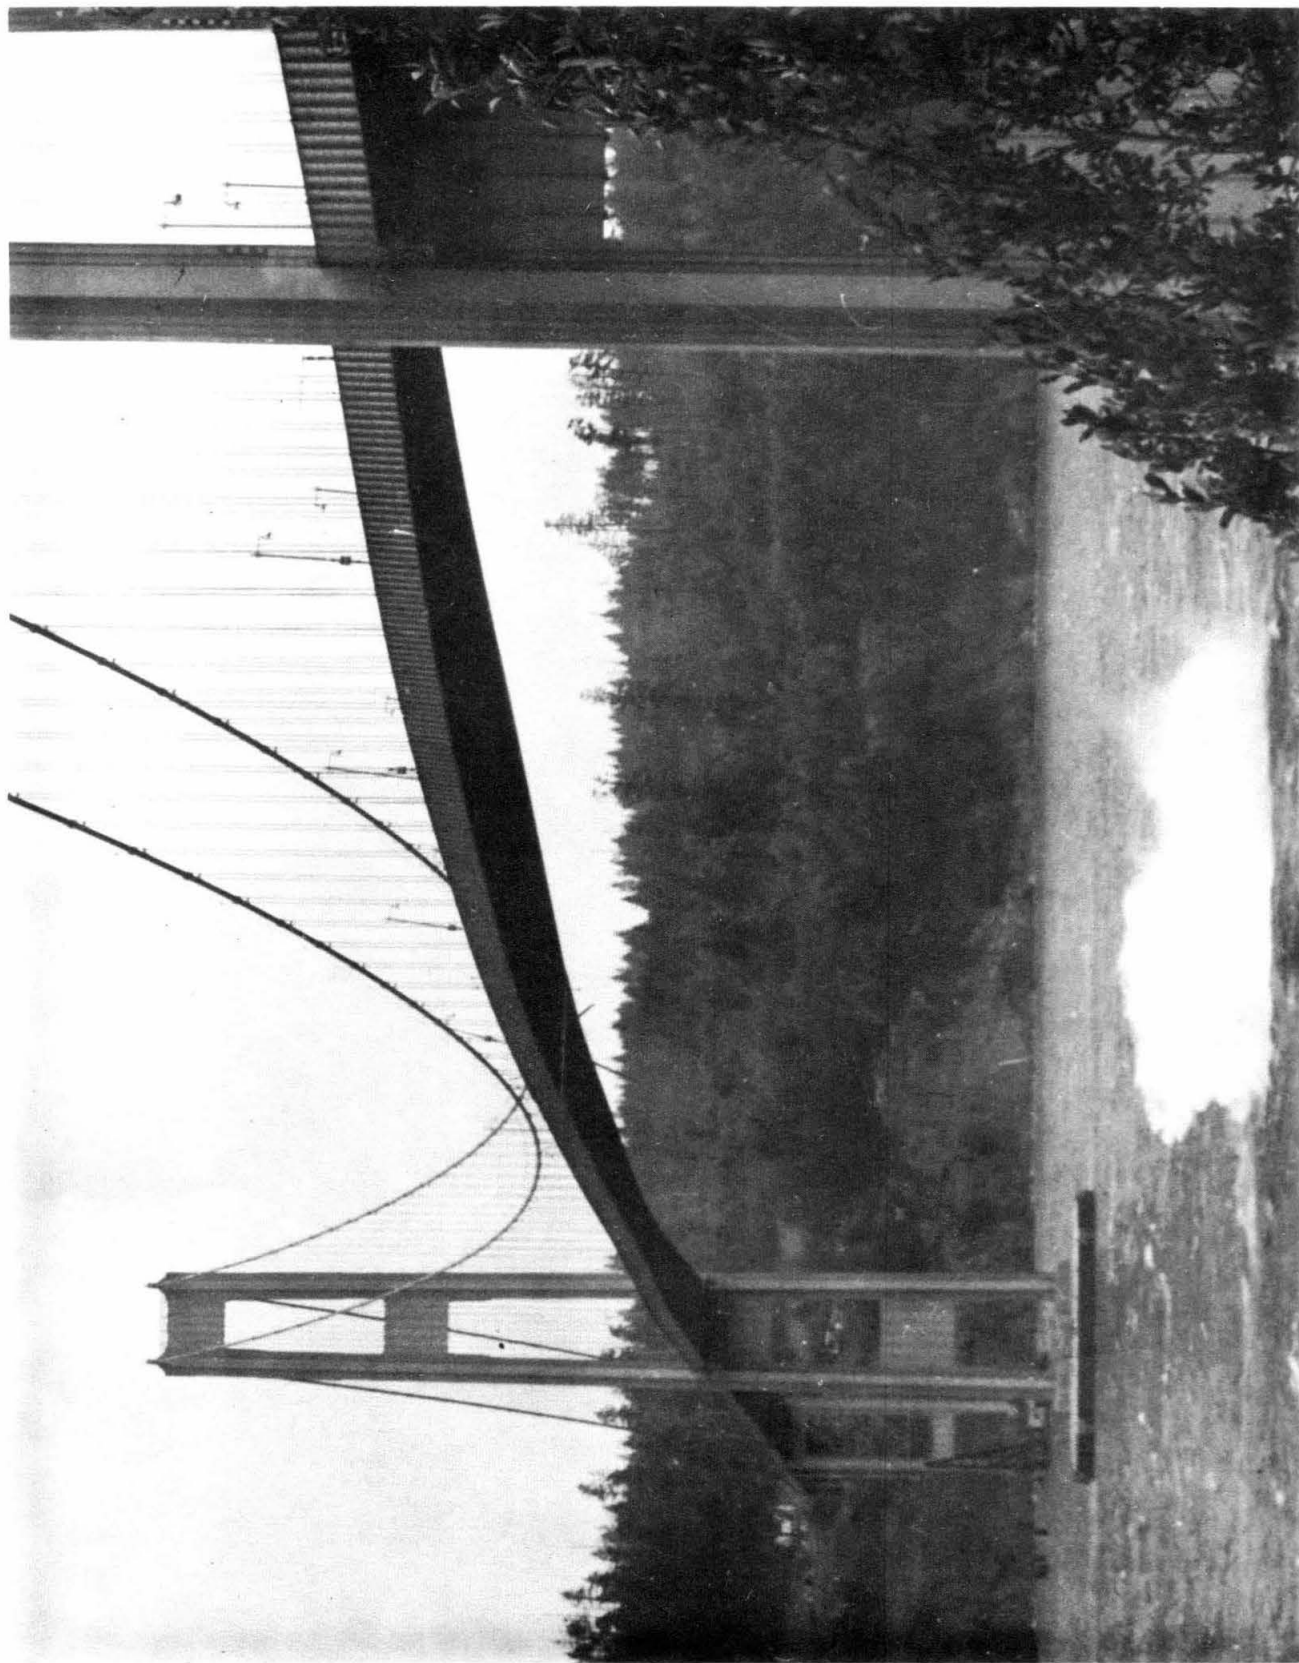
Fig. 4. Failure of Concrete Floor near Mid Span, about 10:30 A.M.

motion, a differential motion between the concrete sidewalk slab and the girders was observed. The torsional movement at times changed to a different mode but soon returned to the single noded motion. About 10:30, a section of the concrete roadway slab dropped from the center of the bridge and photographs show a panel of laterals hanging from their center connection.

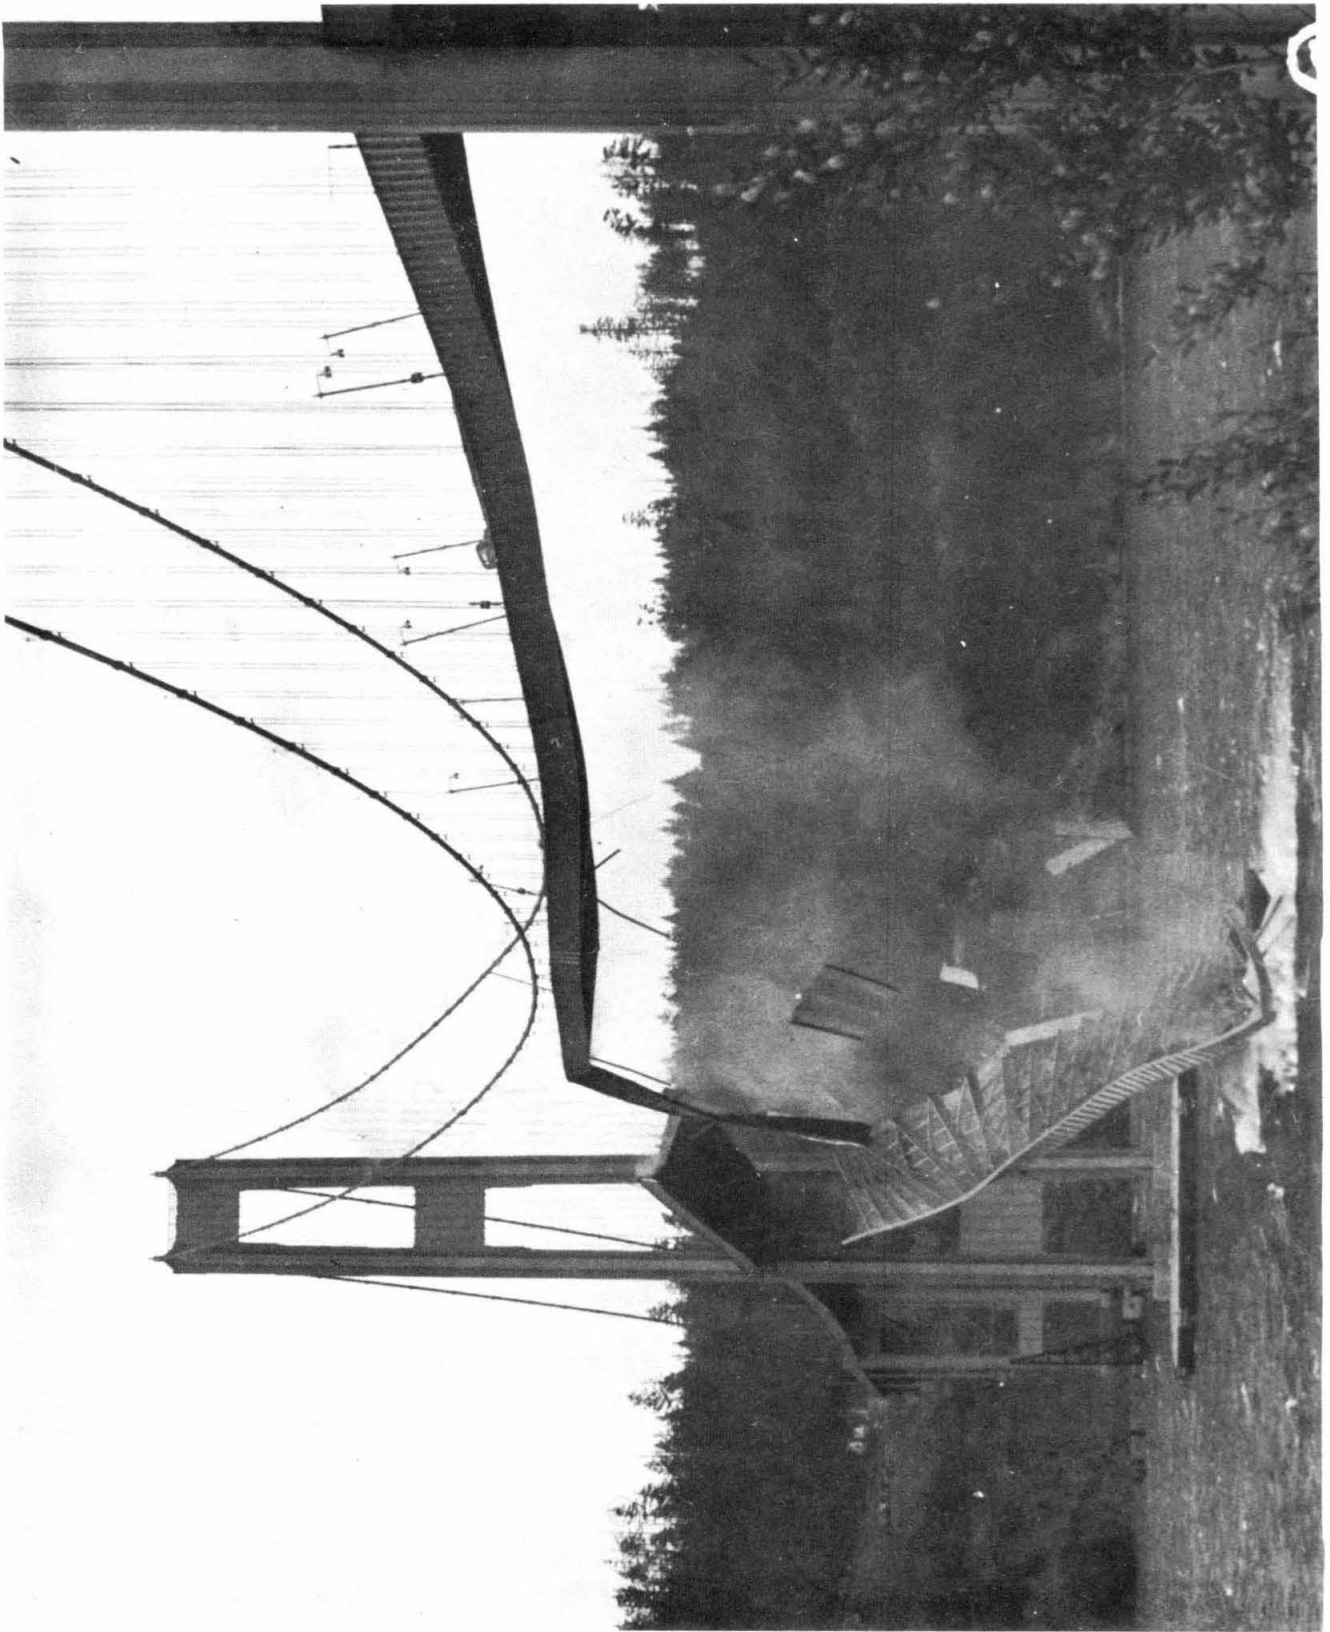
Fig. 5. Dropping of 600 ft. Section of Floor Structure at  
West Quarter Point of Center Span about 11:00 A.M.

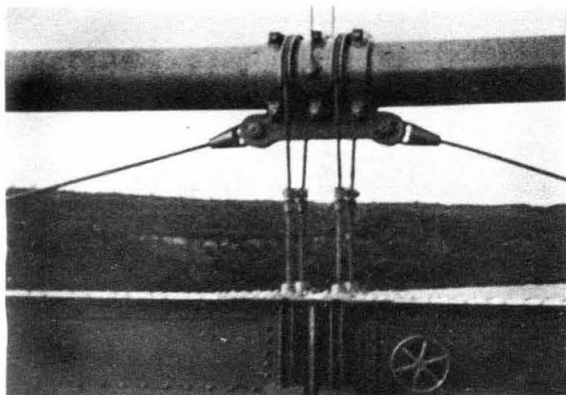
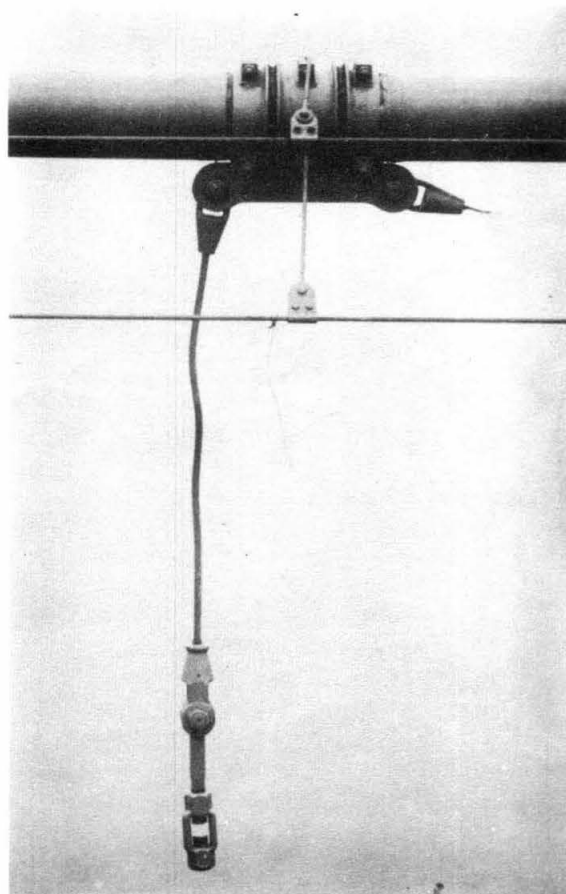
Fig. 6. Center Ties. (a) and (b) are of north cable taken at 9:30 A.M. on day of failure. (b) shows slackness of diagonal tie: (c) center of north cable after failure. About 500 wires are cut and longitudinal movement had amplitude of about 3-1/2 ft. Note missing bolts. (d) south cable after failure.

either 8 or 9 nodes with a frequency of 36 to 38 per minute. There appears to have been no instrumental measurement of the amplitudes. The opinion of witnesses (Appendix V) is that they were no larger than had previously occurred. Figs. 6(a) and (b) are enlargements of single frames of motion pictures taken by Walter Miles of the Pacific Bridge Company at 9:30 A.M. on the morning of the failure and are of the north center tie. These pictures show, the complete film much better, a decided longitudinal motion of the center of the cable in relation to the center of the suspended span. From these pictures, it is evident that the diagonal guys became alternately slack and, therefore, partially ineffective. This slackness permitted greater amplitudes of the relative motions between the cable and the suspended structure; and, motions of these amplitudes had a material effect on the stresses in the center tie. The pictures show that the motions, largely as a result of the slackness, were accompanied by severe impact.

1. Statement of Lt. Hogan.- Appendix V.
2. Figs. 6(a) and (b), above described, was taken at approximately 9:30 A.M. on the day of the failure. The motion pictures show that there was no slipping of the band at this time. Fig. 6(c) shows the cable and band at this point taken after the accident. About 500 wires were literally worn or cut through by the movements of the band. The amplitude of the motion was about 42 inches.

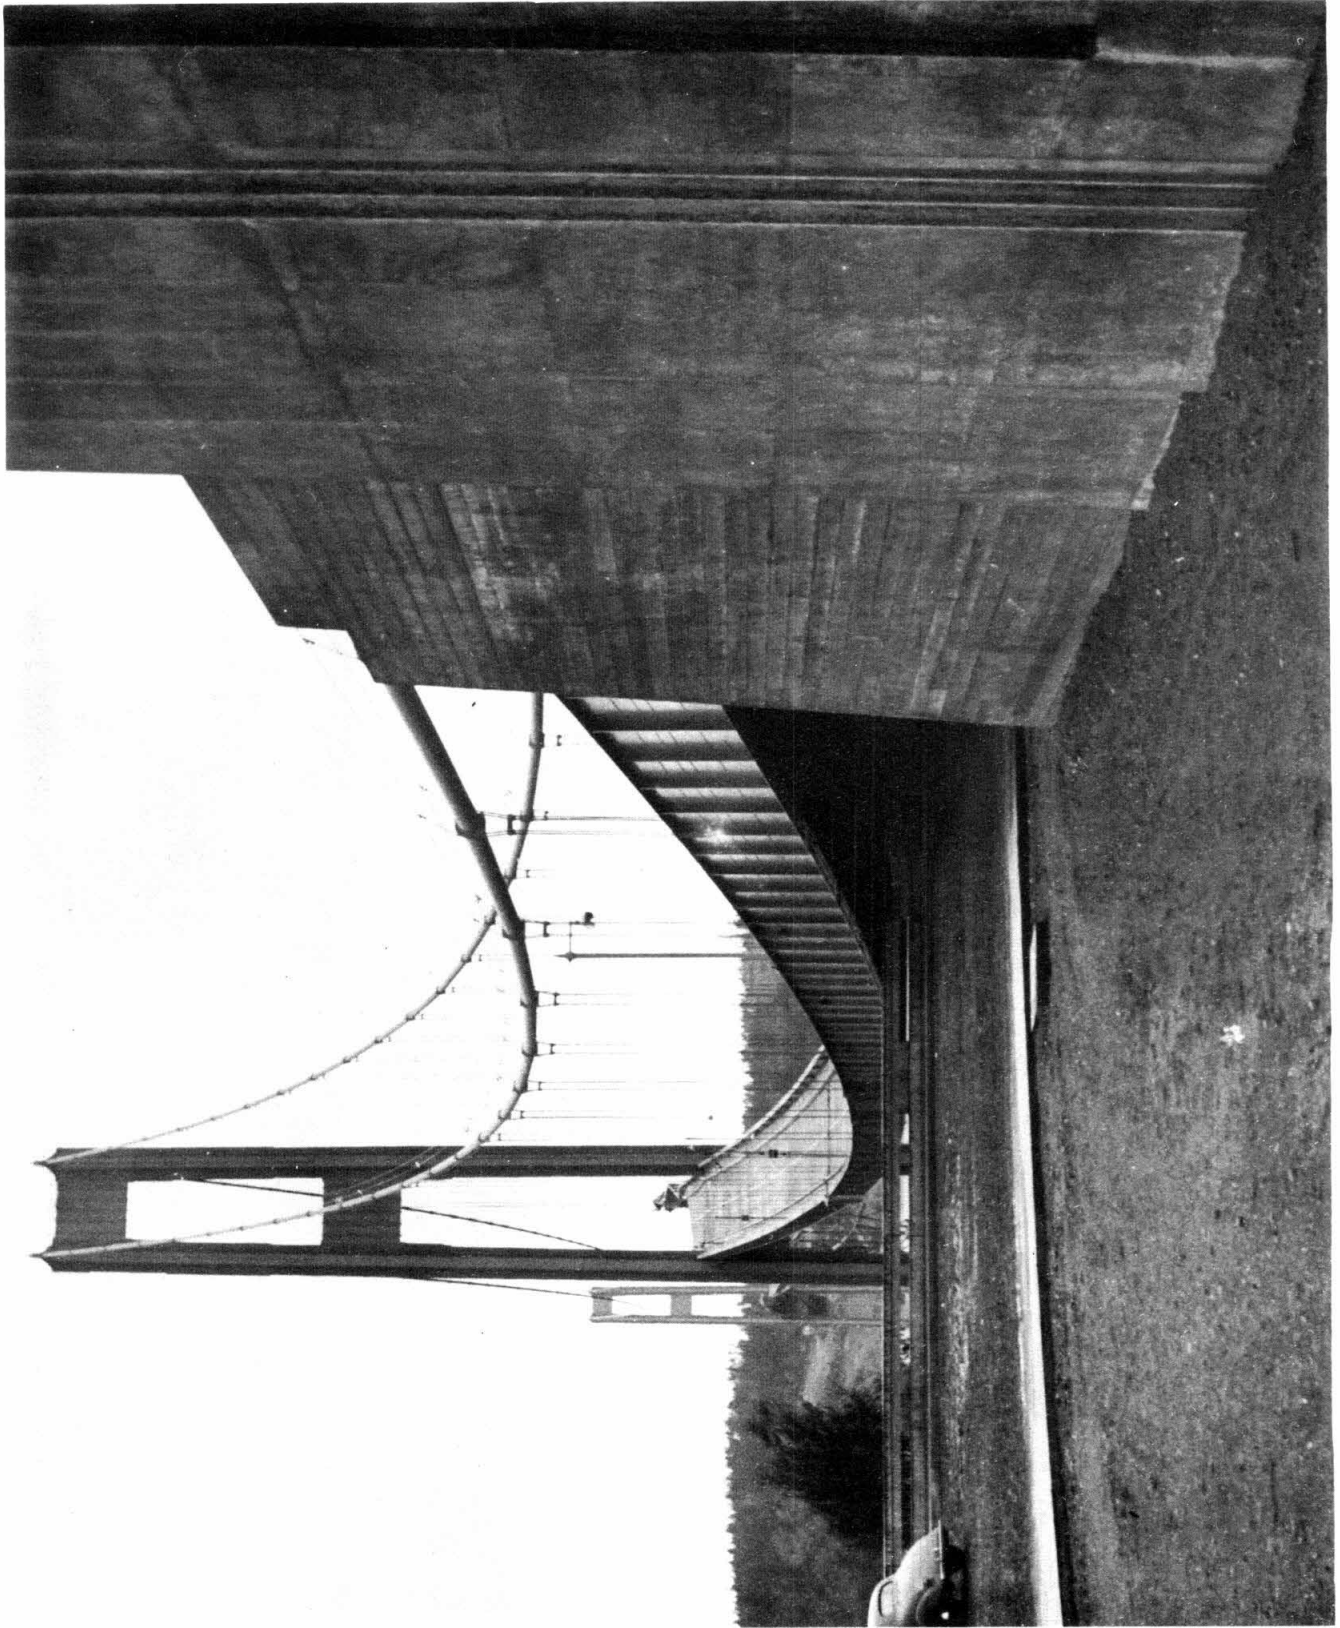
Fig. 7. Sagging of East Side Span after Dropping of  
Center Span of Suspended Structure.

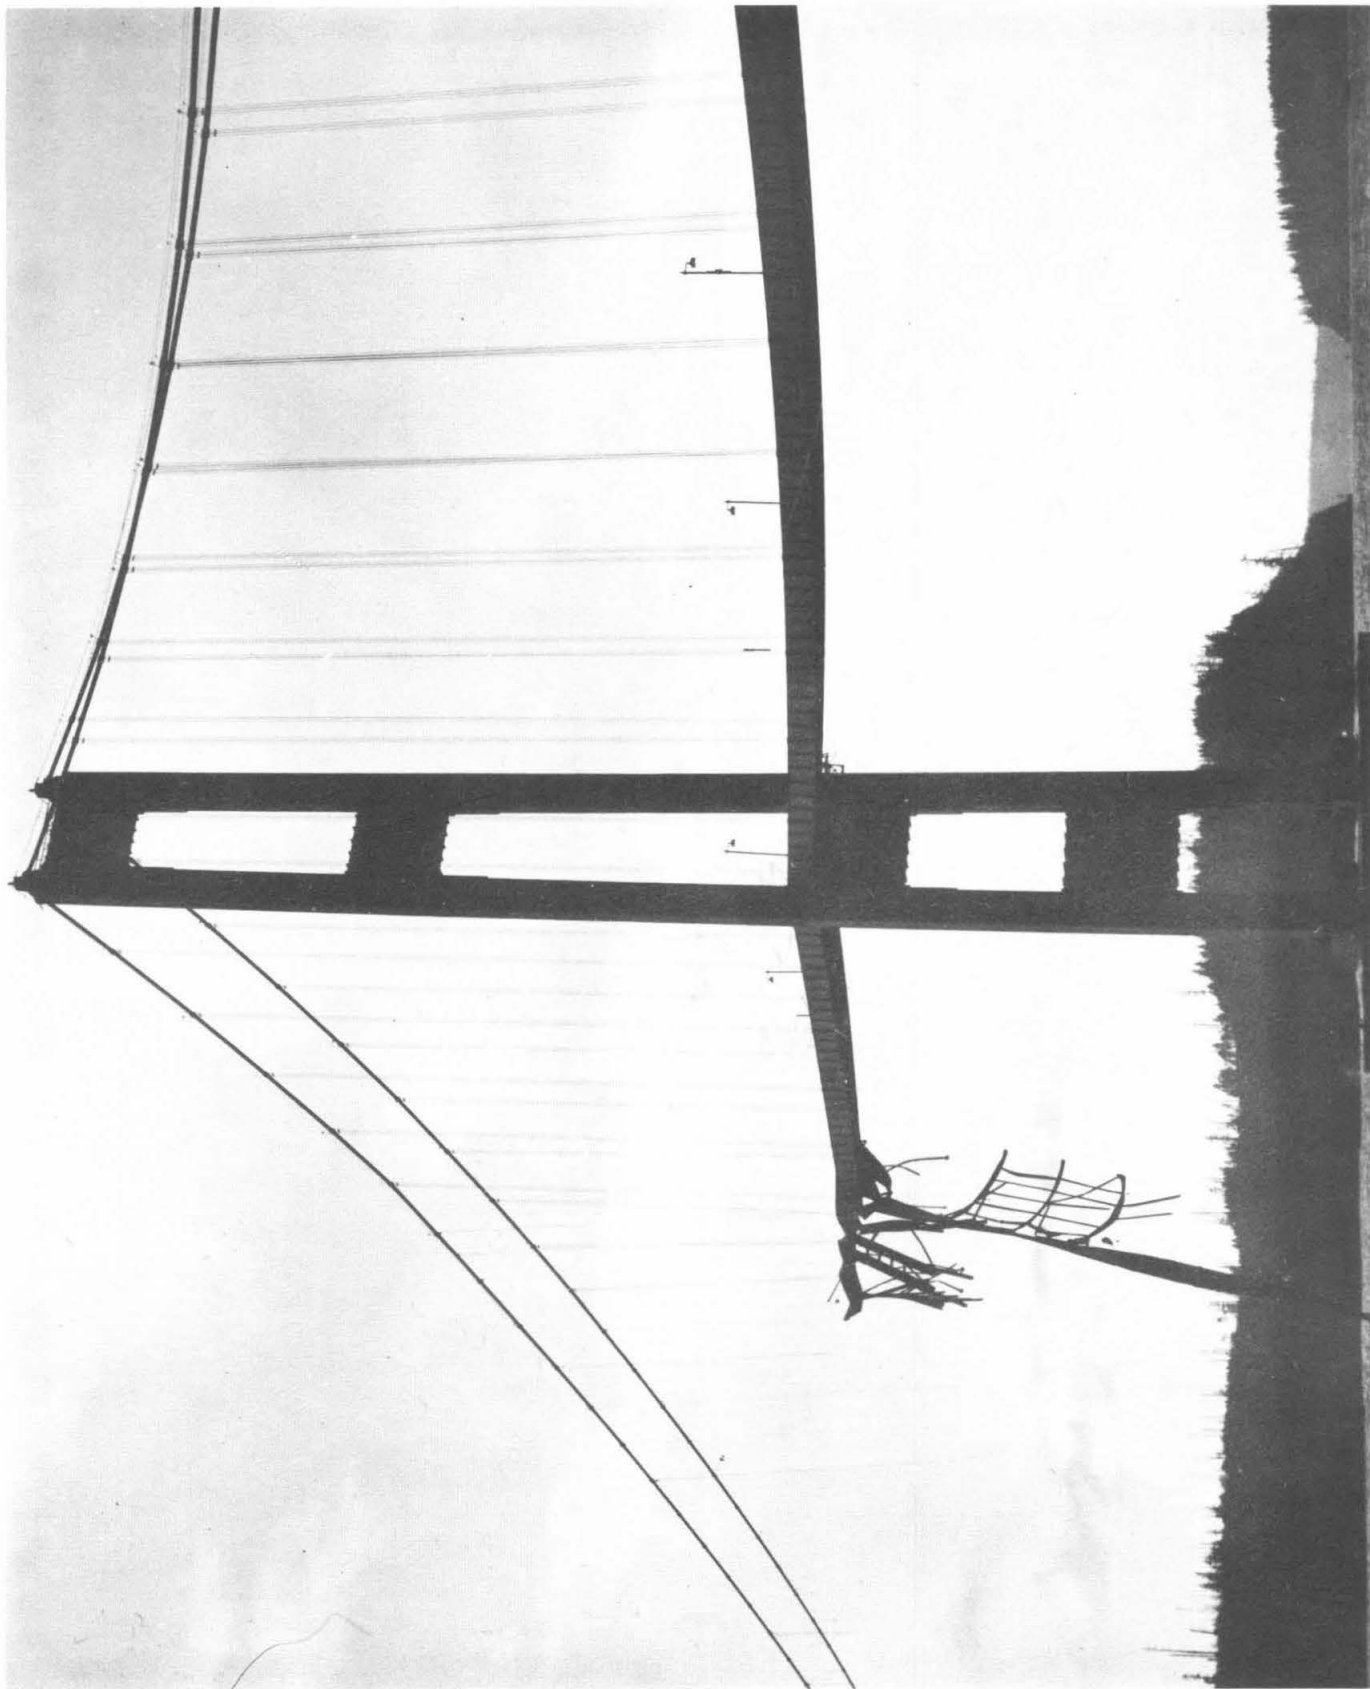
Fig. 8. Conditions Near West Tower After Failure.

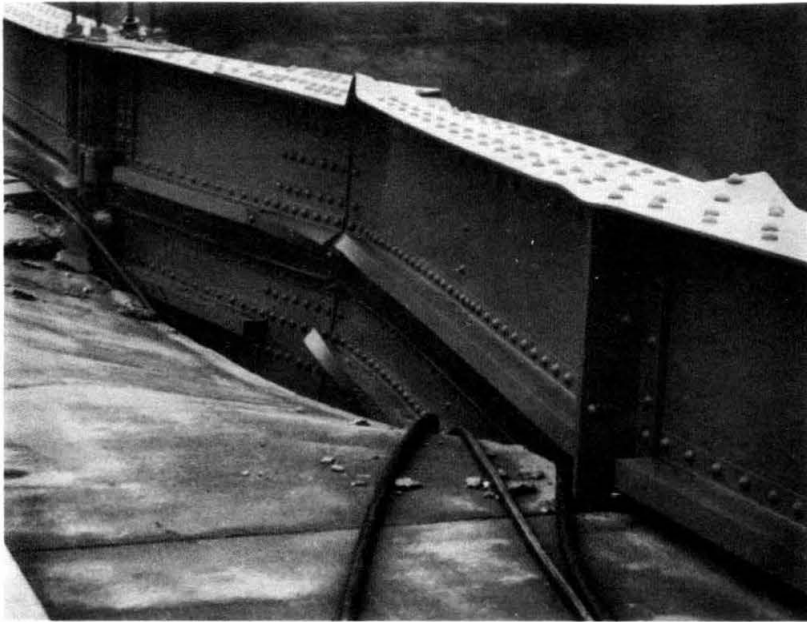
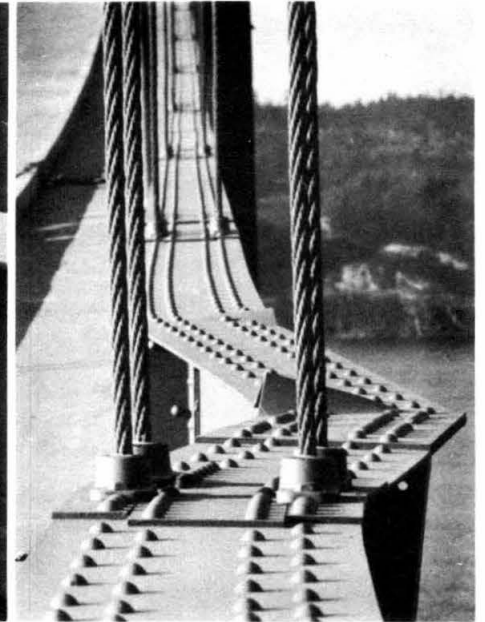
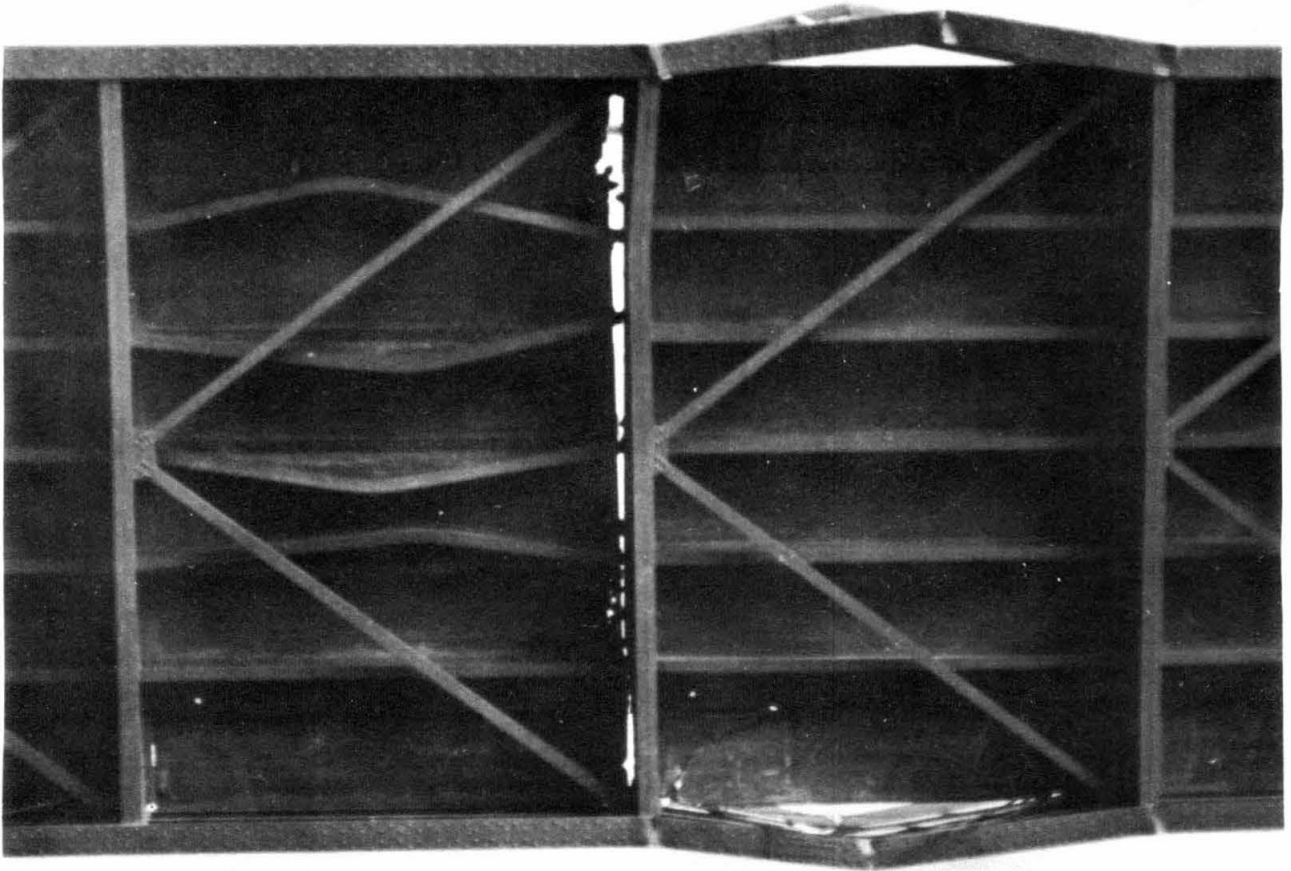
Fig. 9. Buckling of Suspended Floor between Floor beams  
near Center of Side Spans.

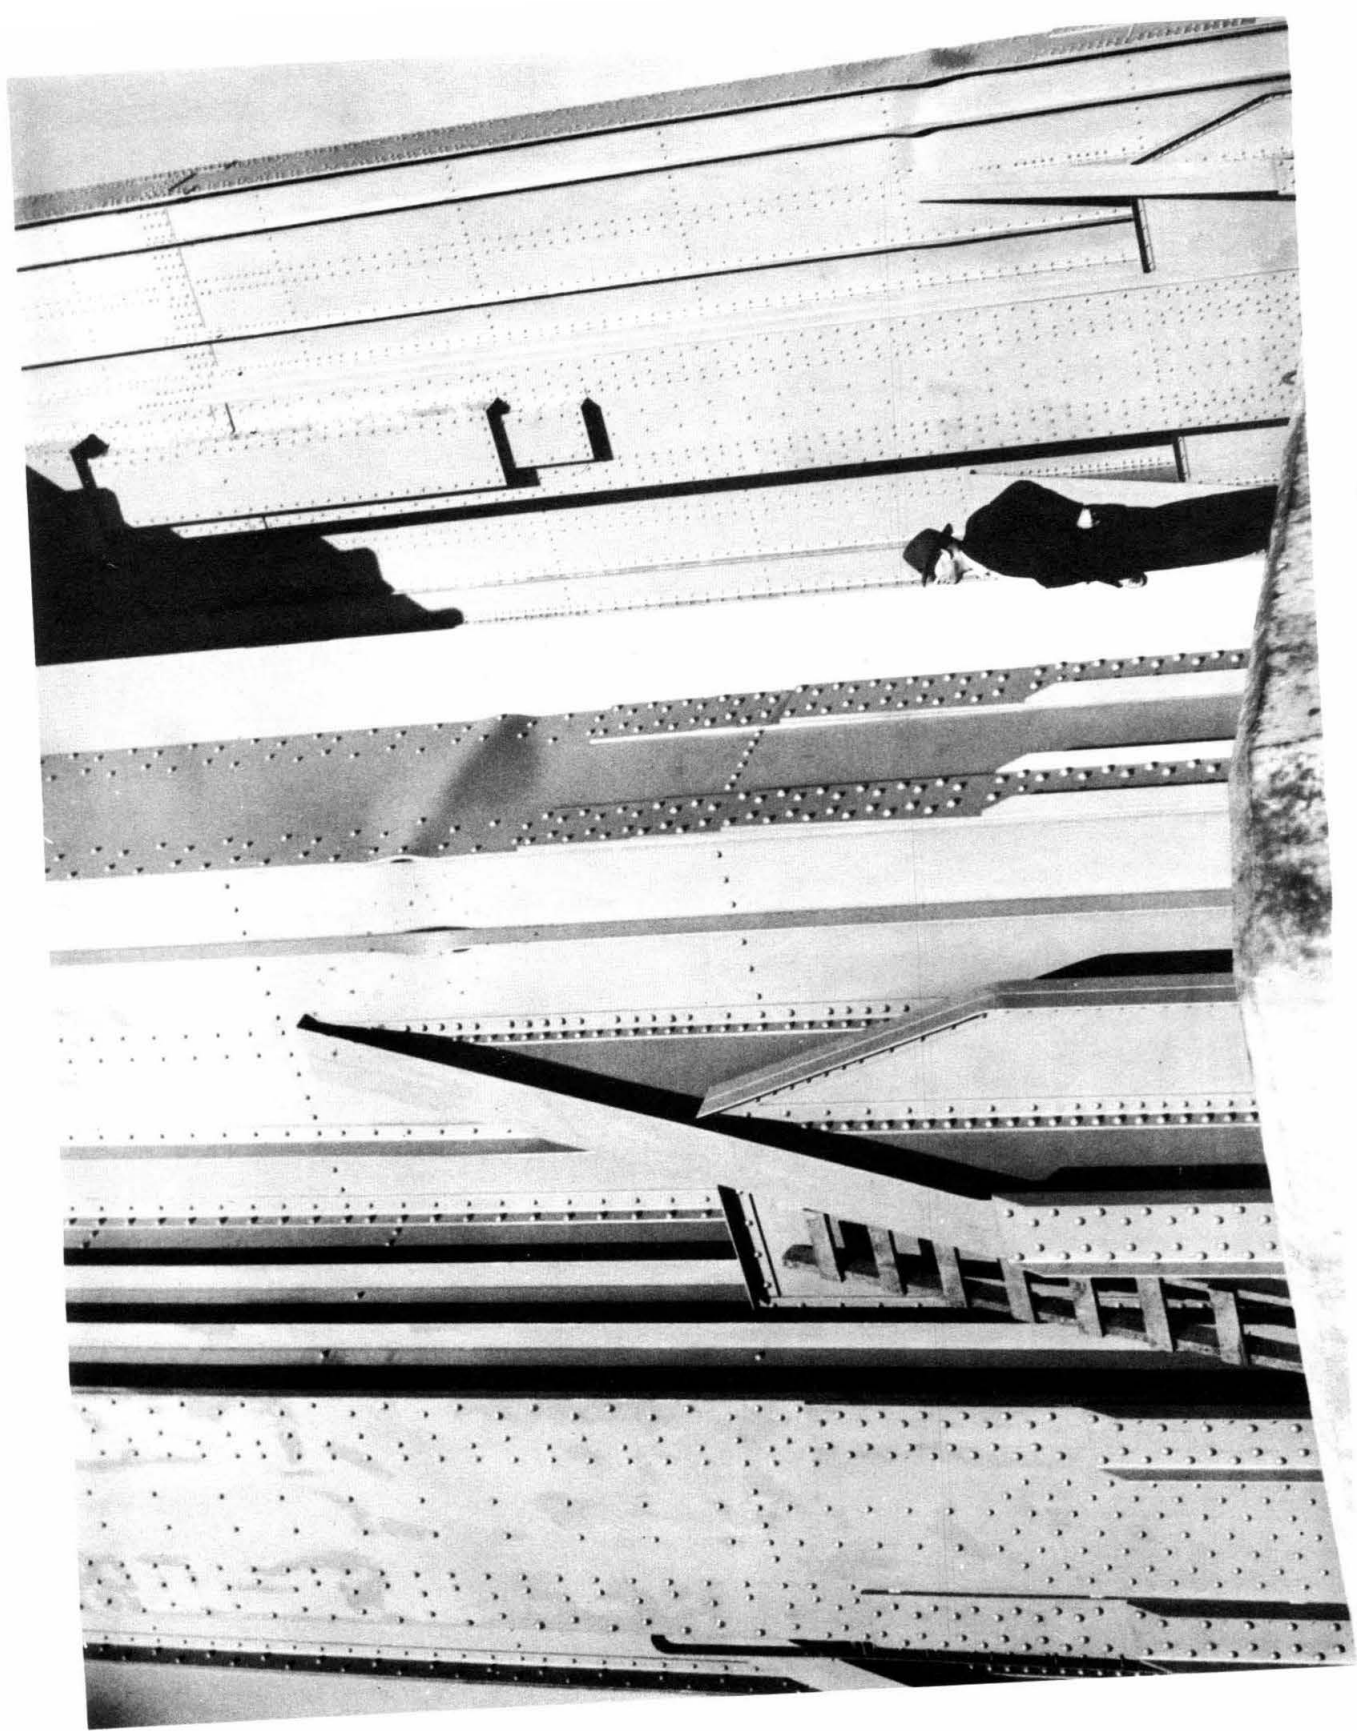
Fig. 10. Buckles on Shoreward Side of Tower near Base.

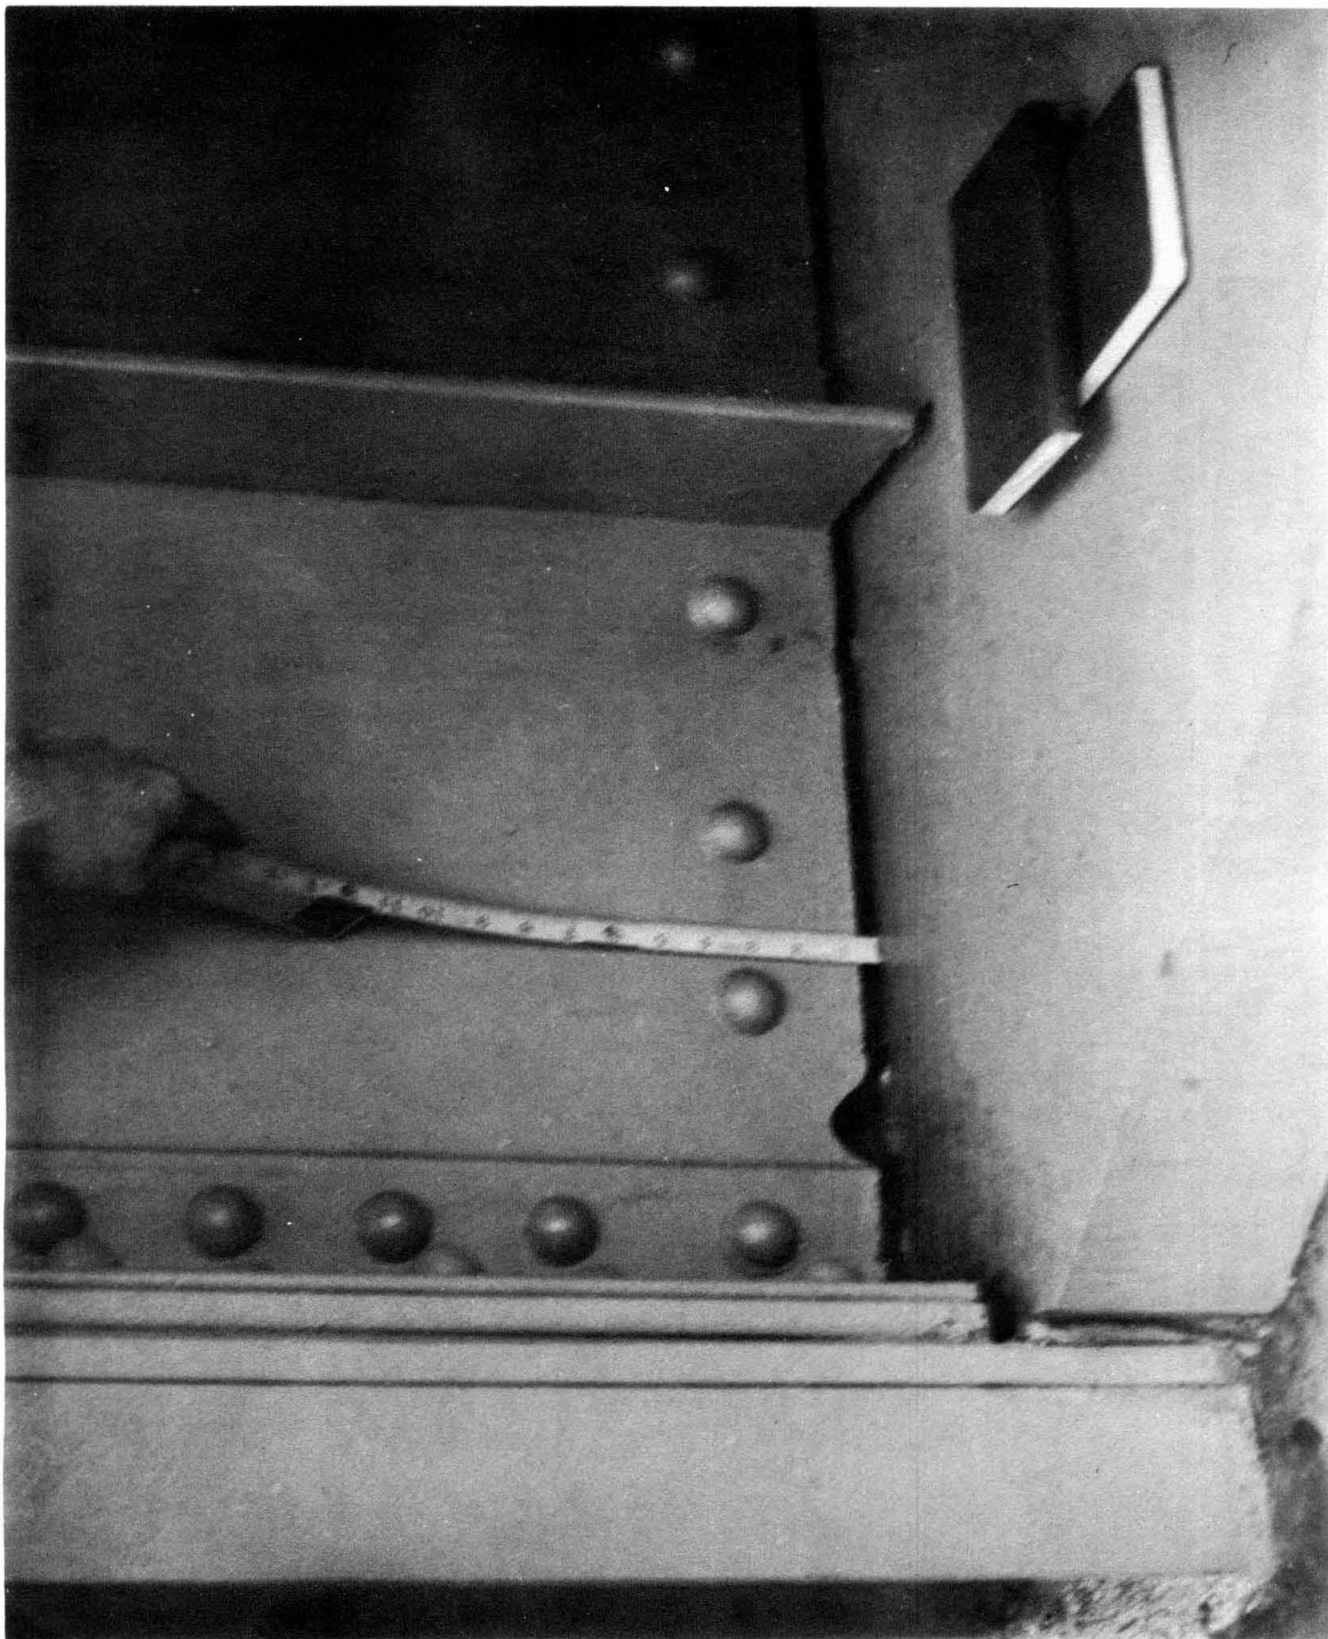
Fig. 11. Opening of 1/2 Inch between Tower Shaft and  
Base Plate on Riverward Side of Tower Shaft.
